ORE PASS REHABILITATION – CASE STUDIES FROM IMPALA PLATINUM LIMITED

*L J Gardner – Rock Engineering Manager: Projects, Impala Platinum Limited
N D Fernandes – Manager: Rock Engineering, Impala Platinum Limited*

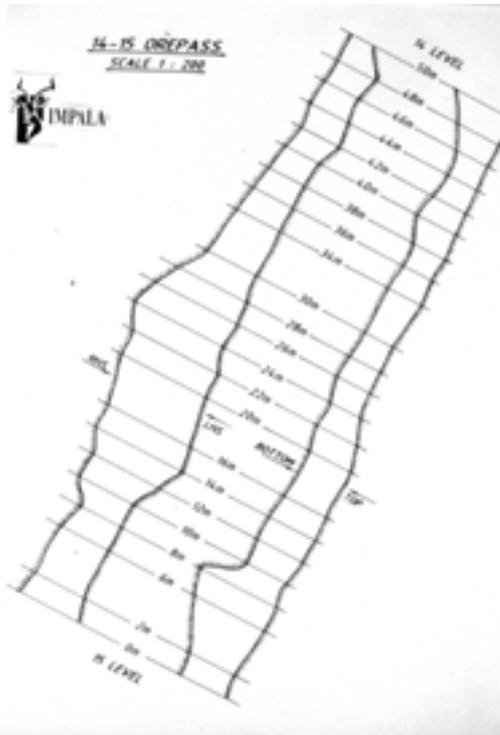
Figure 1 – sections through ore pass

This ore pass, which runs from 975 to 1040 metres below surface, was commissioned in early 1986 and rehabilitated in mid 1987. Although situated in noritic Footwall 16 host rock with a UCS of over 200 MPa, the ore pass traversed very blocky replacement pegmatoid material, as well as several infilled lamprophyre (kimberlitic) dyke structures, which deteriorated due to exposure, water flow and abrasion from the ore flow.

Prior to rehabilitation, the ore pass was thoroughly surveyed to determine the extent of deterioration (figure 1), and offsets were taken at fixed intervals down the length of the ore pass (figure 2). The survey showed that the ore pass's original 3.5 m diameter had increased to a maximum of 24 m in one area. There was however sufficient clearance remaining between this and the other inter-level ore passes, therefore a reinforcement strategy was adopted.

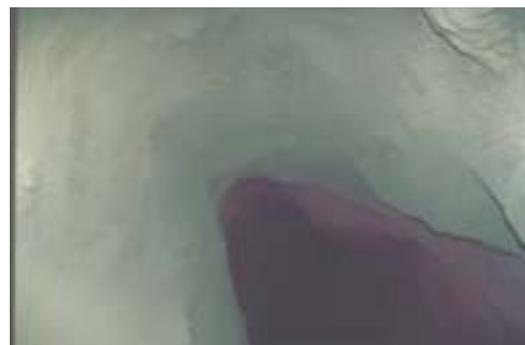
Figure 7 – showing ore pass after completion of rehabilitation process

Despite the trial-and-error nature of the exercise, the rehabilitation progressed smoothly with only minor delays due to material shortages and excessive working heights. No accidents or injuries occurred during the rehabilitation process, which took approximately 6 months and cost R 1.2 million. To date, no further significant deterioration has occurred and the ore pass continues to operate.

It was originally intended to begin all work at the top of the ore pass and work downwards; stripping from the top as work progressed. This proved logistically impossible due to the difficulty of removing all the material and equipment through the ore pass chute on 15 level. Instead, the grouting, meshing and lacing work progressed downwards (figure 6), after which the shotcreting was done in reverse (figure 7), with stripping taking place from the bottom upwards behind the shotcreting operation.

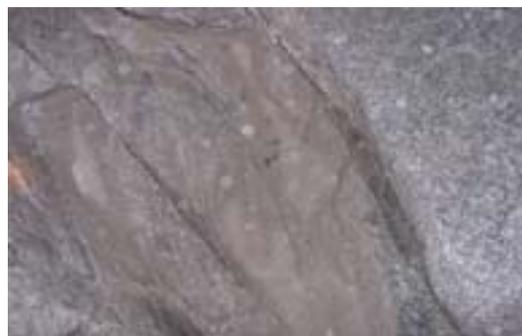
Figure 9 – showing lining eroded on lamprophyre dyke exposure

The support of the seven silos, which was conducted by contractors, took approximately 9 months to complete, with no serious incidents being recorded. Following their commissioning in 1996, the silos have functioned successfully to date, with the only significant deterioration in the lining having occurred along the lamprophyre dyke zone (see figures 8 to 11)

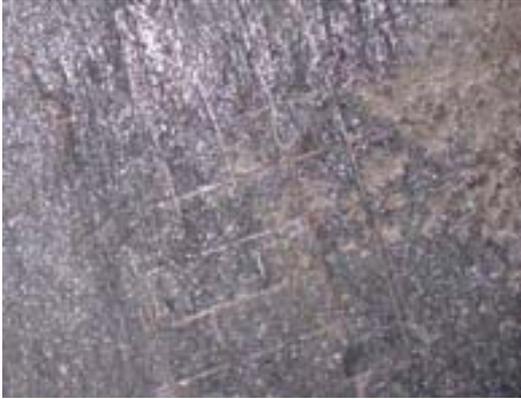
Figure 10 – showing shotcrete eroded to partially reveal weld mesh

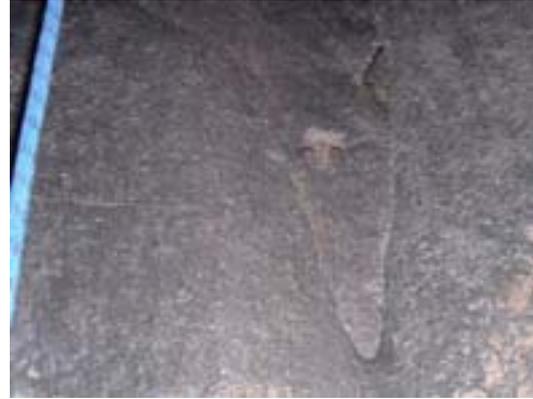
Figure 11 – showing minor exposure of lamprophyre dyke in silo

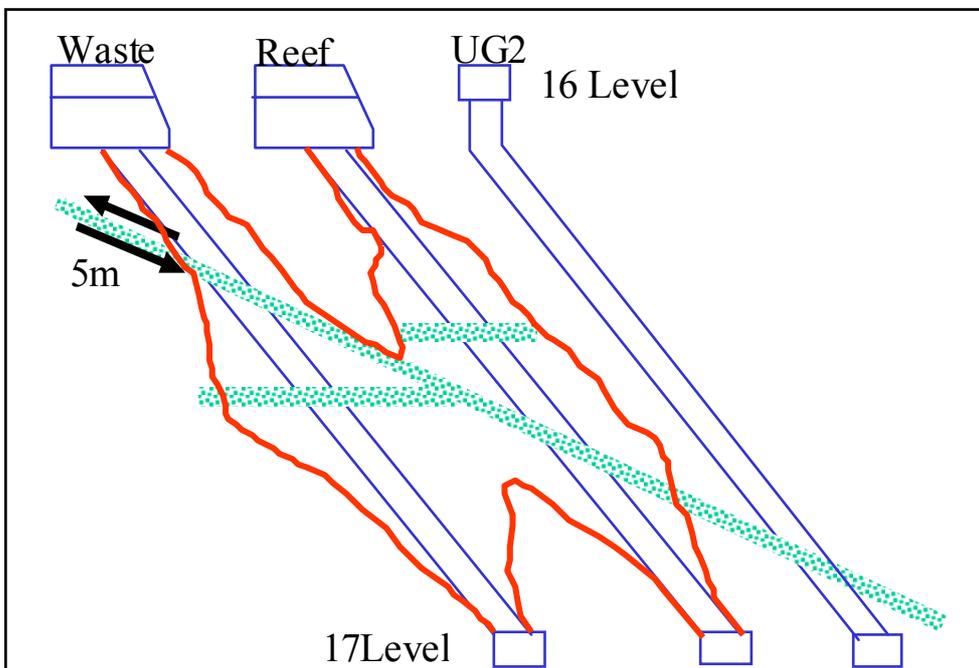
Serious delays were experienced during the initial making safe and support phase as the reef pass emptied faster than the waste pass when bled, preventing simultaneous work from taking place until such time as the holing point had been reached. When the holing cavity was finally exposed, the damage was found to be more severe than initially anticipated.

Figure 12 – showing holing between ore passes and reverse fault position

The semi-elliptical shaped holing had occurred in the layered footwall 16 horizon (see figures 12 and 13). The area was traversed by a 45 degree-dipping reverse fault, together with near-vertical jointing, which resulted in blocky ground conditions. It was also likely that the situation could occur in the newly-developed adjacent UG2 ore pass, which intersected the same features.

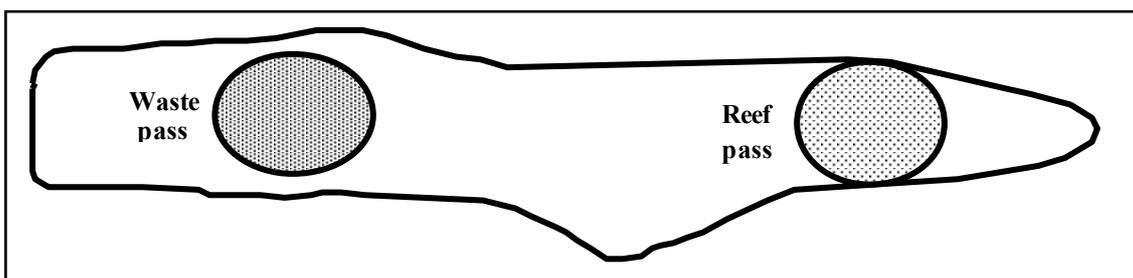
Figure 13 – plan view showing profile of holing between ore passes at widest point

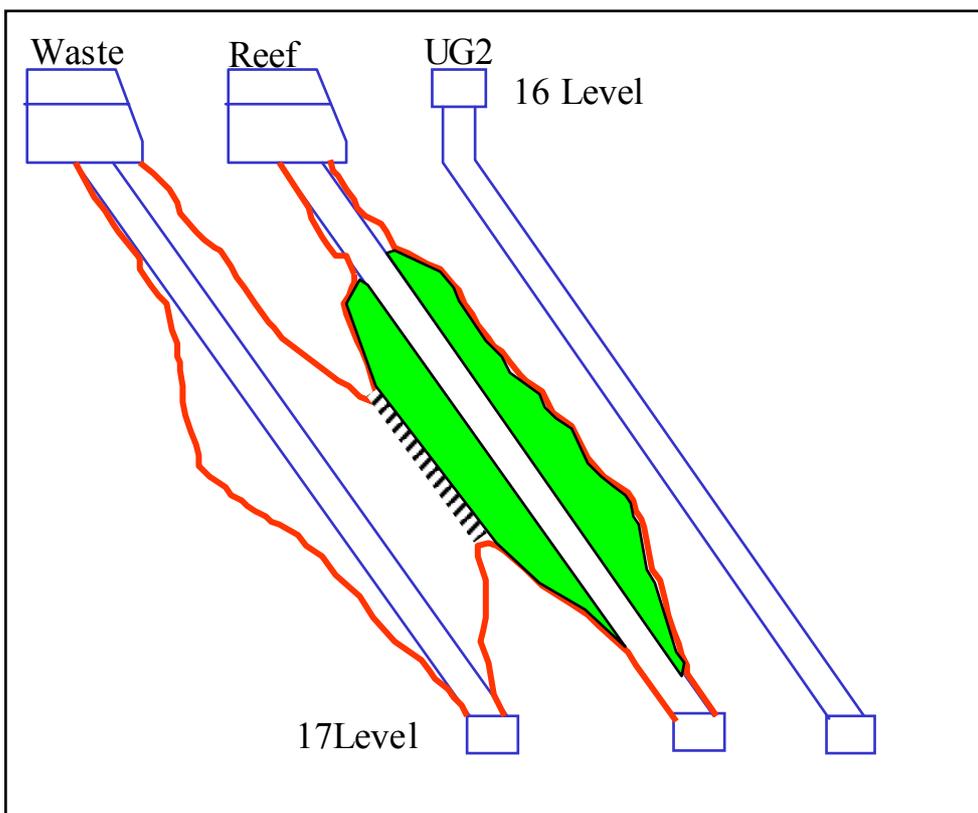
Figure 14 – showing position of brattice wall and filled area in reef ore pass

After assessing the extent of the damage, it was concluded that the waste ore pass, being the lower of the two, was unlikely to migrate further towards the footwall as a substantial “dead box” of stuff had already formed. Provided its hanging wall was properly supported, further deterioration was unlikely.

A change of project scope was proposed – a brattice wall would be constructed in the holing cavity to separate the two ore passes, then the waste ore pass would be recommissioned (see figure 14). Once the waste ore pass was in use, the reef ore pass would be rehabilitated as originally proposed, while simultaneously rehabilitating the UG2 ore pass. This would have both time and cost advantages, as well as ensuring the future stability of the UG2 ore pass.
