SEISMIC SOURCE MECHANISM CHARACTERISTICS OBSERVED DURING THE BAMBANANI MINE SHAFT PILLAR EXTRACTION

S van der Wath

Rock Engineering Manager, Harmony Bambanani Gold Mine

SYNOPSIS

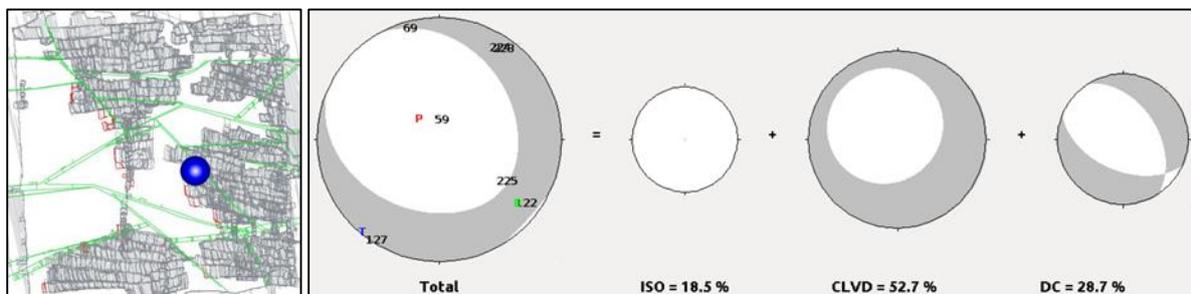
Figure 10 & 11: Ml1.6 seismic event plot at the 71-80 raise line and its moment tensor analysis.

The ISO and CLVD components suggest crush type deformation within the source region.

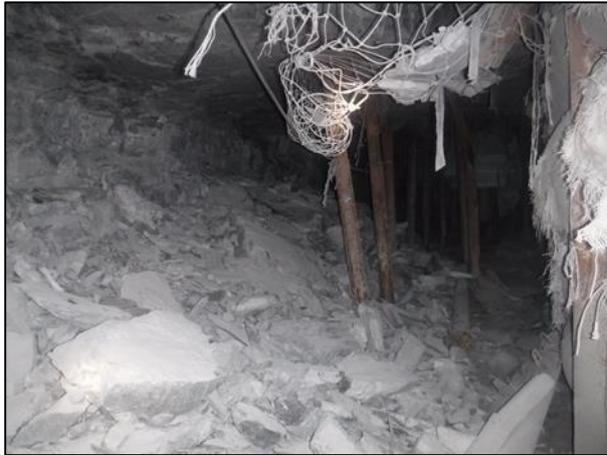
Photo 1: Underground observations panel 71-80 S9 panel face.

Rockburst damage was observed in panel S9 as rock ejected from the panel face. Panel S9 was lagging its top and bottom panels, thus isolating the S9 panel.

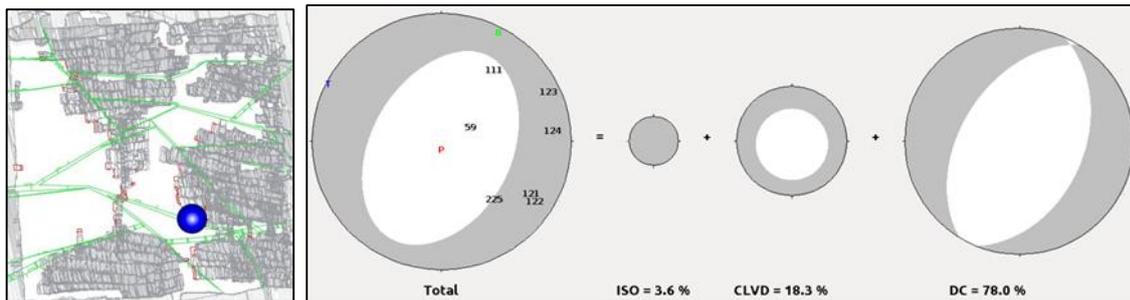
Figure 12 & 13: ML2.7 seismic event plot at the 71-80 raise line and its moment tensor analysis. The estimated source mechanism has a dominant double couple component.

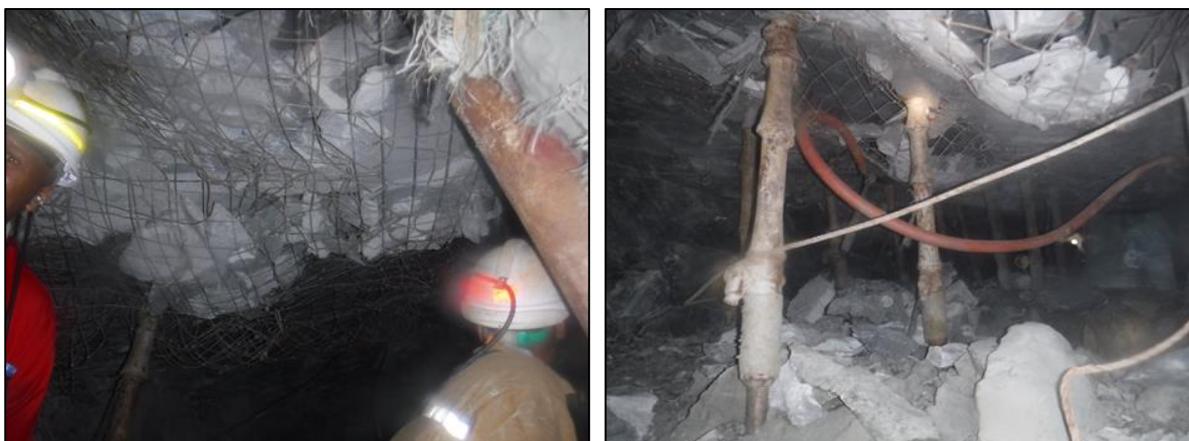
Photo 2 & 3: Underground observations panel 71-80 S3 gully hanging wall (Left) and panel face (Right).

Rock burst damage was observed in the gully and face of panels S3 and S4. Shakedown from the hanging wall was suspended in the netting, supported by props and backfill. Falls of ground also occurred in the face between the last line of support and the face.

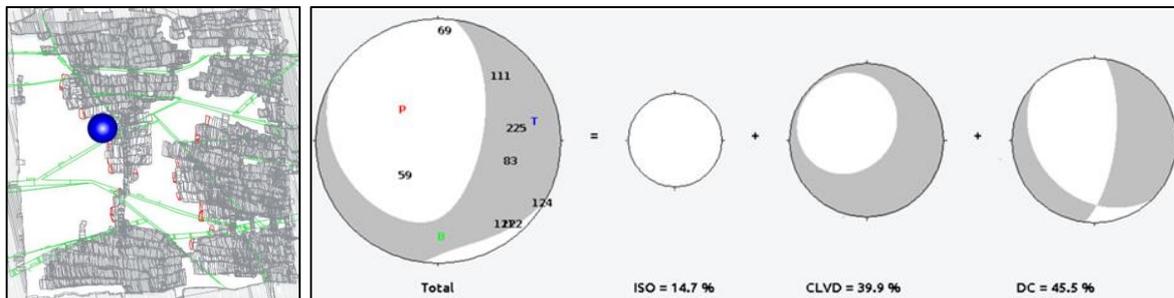
Figure 14 & 15: Ml1.9 seismic event plot at the 69-86 raise line and its moment tensor analysis.

The DC component is dominant suggesting a shear type deformation within the source region.

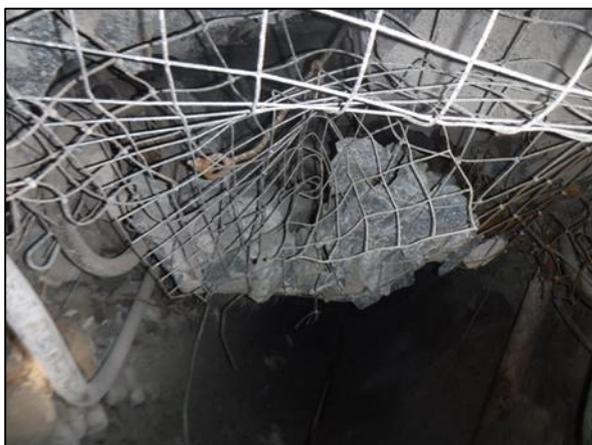
Photo 6: Underground observations panel 69-86 S9 gully.

Rockburst damage was observed in panel S9 gully and siding. Scattered falls of ground was observed suspended in steel netting and welded mesh in the gully and siding. The lead/lag distance between panels S9 and S8 was excessive which resulted in the abutment failure.

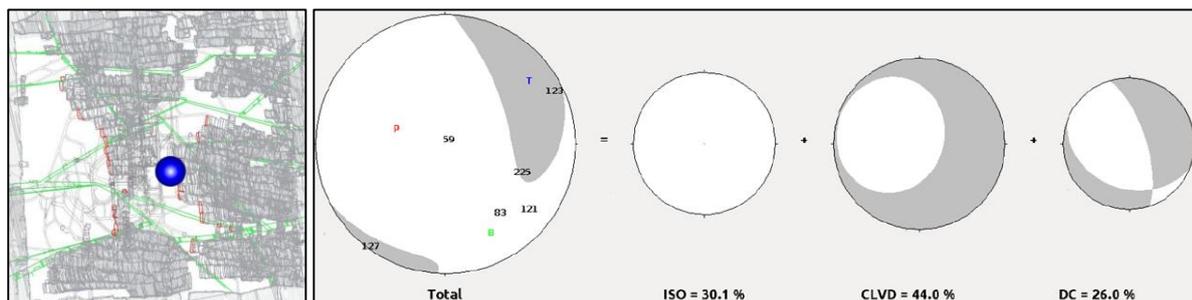
Figure 16 & 17: Ml2.1 seismic event plot at the 71-80 raise line and its moment tensor analysis. The ISO and CLVD components suggest crush type deformation within the source region.

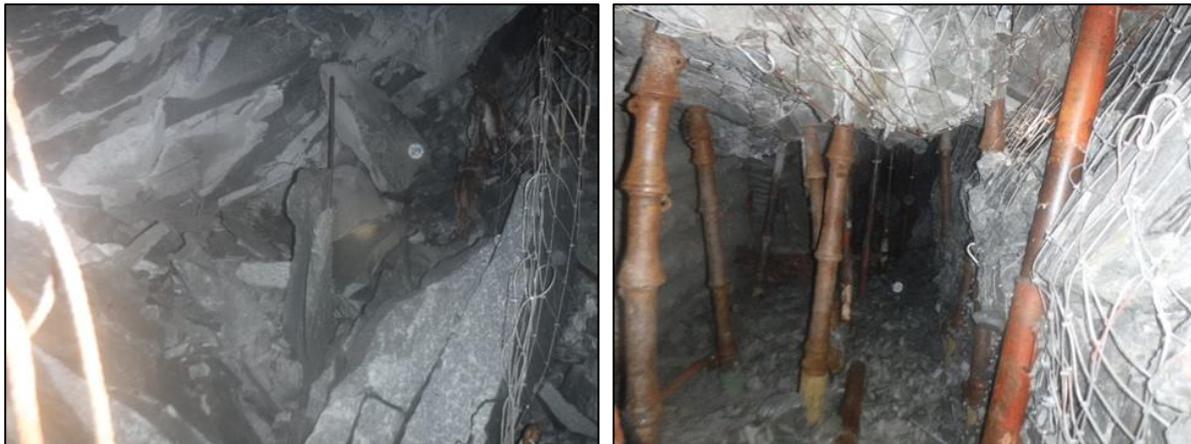
Photo 7 & 8: Underground observations panel 71-80 S7 gully face (Left) and panel face (Right).

Severe rockburst damage was observed in panel S7 with falls of ground observed in the gully and face, with the full face length of the panel ejecting. Rock flour can be seen on the fracture planes in the photo of the gully face hanging wall, indicating the close proximity to the rupture process within the source region. Gully tendons dislodged with the hanging wall rock in the gully. Hydraulic props and steel cable netting kept the panel face open, but large volumes of rock were suspended in the netting from the hanging wall and from the face.

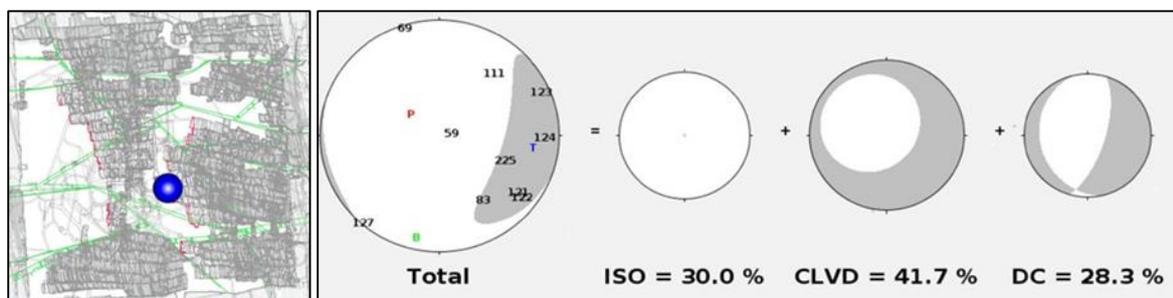
Figure 18 & 19: ML2.4 seismic event plot in the shaft pillar and its moment tensor analysis.

The large ISO and CLVD components suggest a crush type failure mechanism.

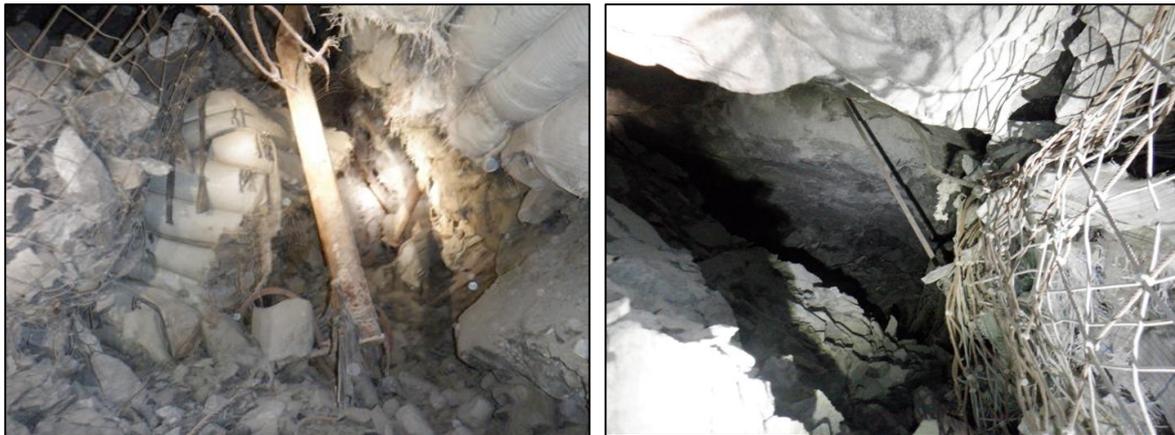
Photo 9 & 10: Underground observations panel 71-80 S6 gully (Left and Right).

Severe rockburst damage was observed in the gully and in the face of the panel, to such an extent that access into the gully (10m back from the gully face) and panel face (toe and mid panel) was not possible. Rock flour was noted on fracture planes in the gully hanging wall, indicating the close proximity to the rupture process within the source region. Gully packs were dislodged into the gully, with hanging wall rocks ejected next to tendons and a hanging wall tendon observed to be bent during dynamic loading. Face ejection with blasted ore from the face and a subsequent fall of ground from the hanging wall, closed the panel face. The total destruction of a headboard observed in the face substantiates the close proximity to the source region. Hydraulic props were shifted back during the event by the face ejection, shifting the blasted ore. The hanging wall beam broke up between props and resulted in significant net sagging up to the blasted ore and ejected rock from the face.

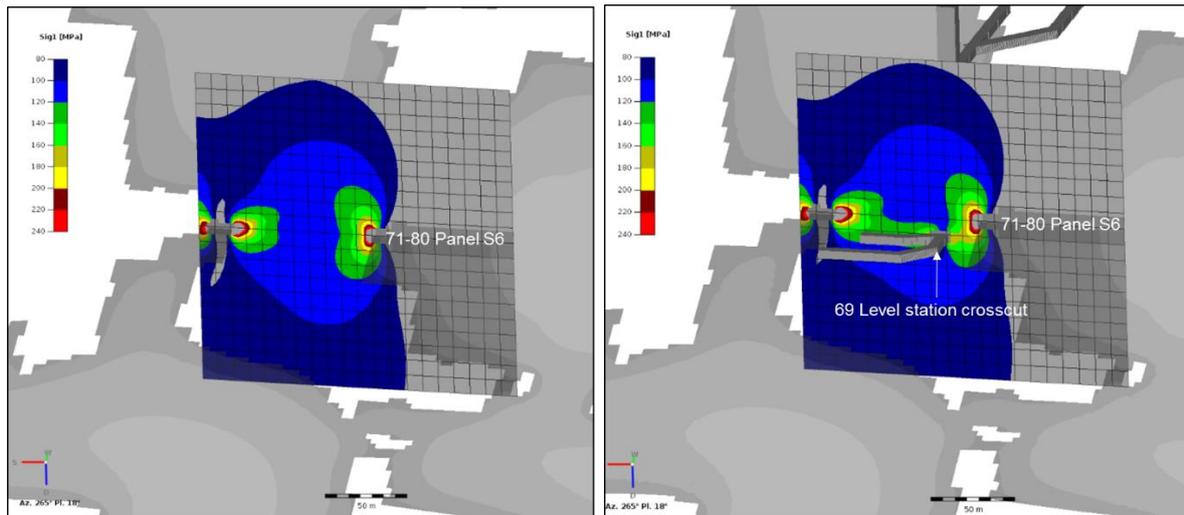
Figure 20 & 21: Vertical sheet of the Sigma 1 stress on the 71-80 S6 panel with and without 69 level shaft infrastructure included.

Initial planning of the shaft pillar extraction was to sacrifice the Main and Sub shafts and its infrastructure below 60 level, which included large excavations like hoist rooms, shaft barrels, shaft stations, dams and crosscuts. Monthly numerical modelling was conducted of the shaft pillar mining, but this only included stoping excavations and did not indicate any anomalous conditions. When adding the shaft infrastructure excavations into the model the Sigma 1 stress lobe interaction between the stoping and the shaft infrastructure becomes apparent, as seen from the figures above. The holing into the shaft infrastructure is thus not only a holing risk, but also a seismic risk as the isolated block between the excavations is overstressed, especially in the final remnant with elevated levels of stress.

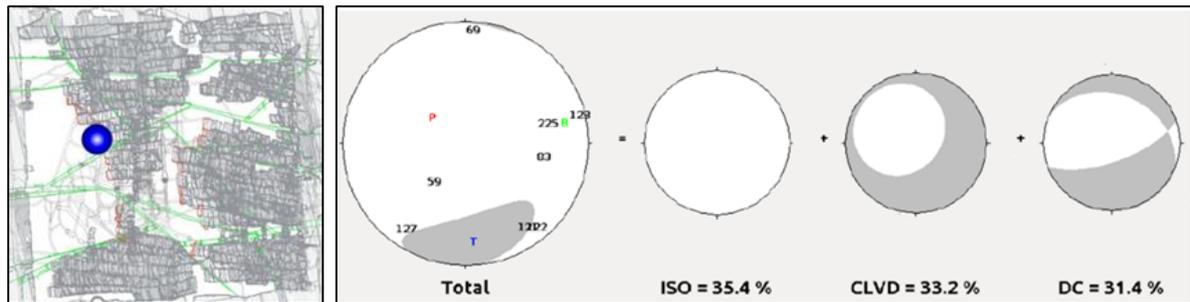
Figure 22 & 23: MI2.3 seismic event plot in the shaft pillar and its moment tensor analysis.

The nodal planes of the DC component align with the panel faces. ISO and CLVD components also suggest volumetric type deformation within the source region.

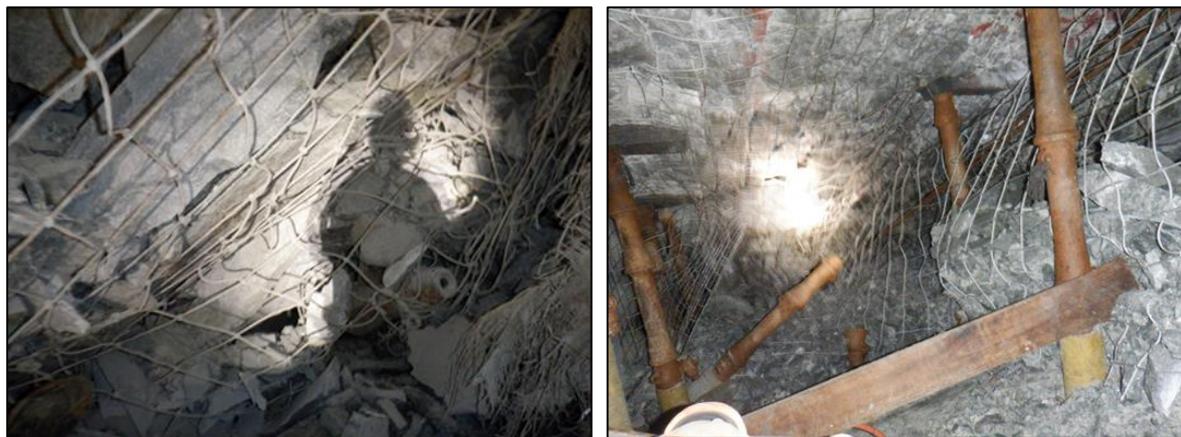
Photo 13 & 14: Underground observations panel 69-86 S9 face toe (Left) and face top (Right).

Severe rockburst damage was observed in the gully and in the face of the panel, to such an extent that the toe of the panel could not be accessed. The full face length of the panel ejected increasing in intensity as observed on the stretch of face nets, towards the bottom of the panel. Footwall heave was observed on the footwall of the panel. Hanging wall rock ejected next to tendons in the gully. The hydraulic props in the bottom which could be observed from the back area, were shifted out of position by the rock from the face ejection. This resulted in the hanging wall in the toe of the panel, to fall. The severity of the observed face ejection in the bottom of the panel confirms the close proximity to the source region.

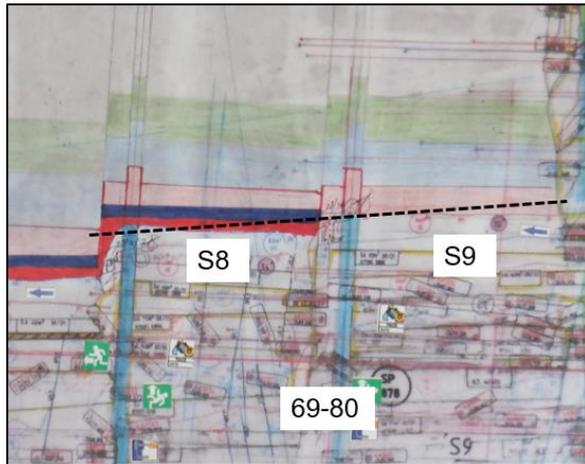
Photo 15: Stopping panel face configuration in line, forcing shear rupture on the face abutment.

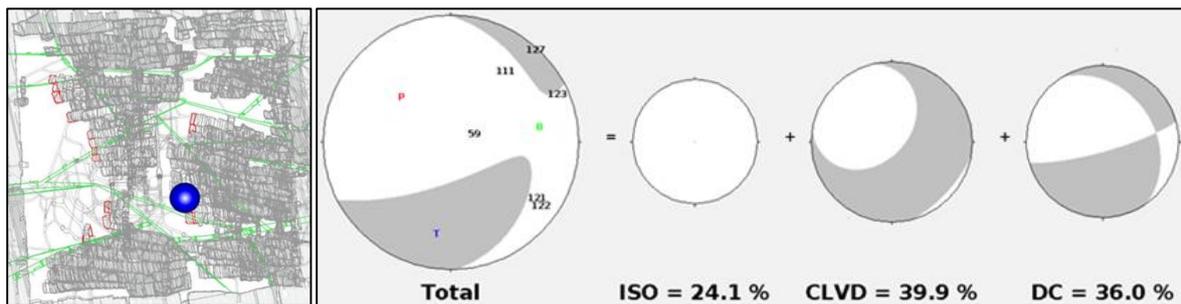
Figure 24 & 25: Ml1.7 seismic event plot in the shaft pillar and its moment tensor analysis.

The nodal planes of the DC component align with the panel faces and the ISO and CLVD components suggest some volumetric type deformation within the source region.

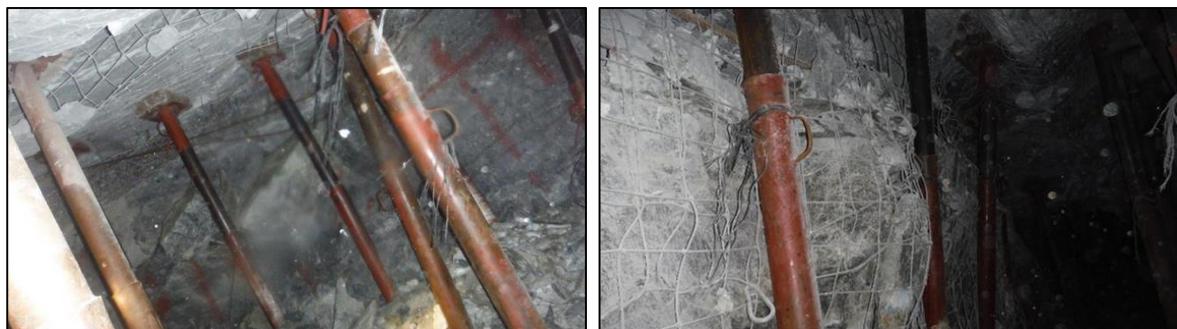
Photo 16 & 17: Underground observations panel 71-80 S3 face (Left) and S4 face (Right).

Rockburst damage was observed on both the panel faces. Large slabs loosened on S3 panel face and the face in panel S4 ejected. Hydraulic props and face netting secured all the ejected rock. The significant damage on panel S4 face is expected as this is close to the source region.

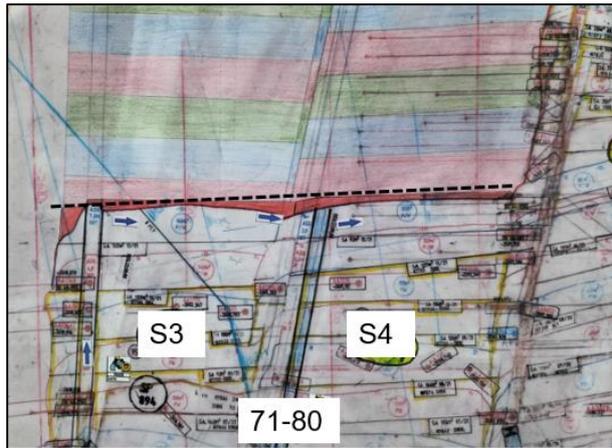
Photo 18: Stopping panel face configuration in line, forcing shear rupture on the face abutment.
