NEGOTIATING COMPLEX GEOLOGICAL STRUCTURES BY APPLYING NEW MINING STRATEGIES

X Qamata – Mine Manager, Millsell & Waterkloof Mines

C J Steenkamp – MRM Manager, Western Chrome Mines

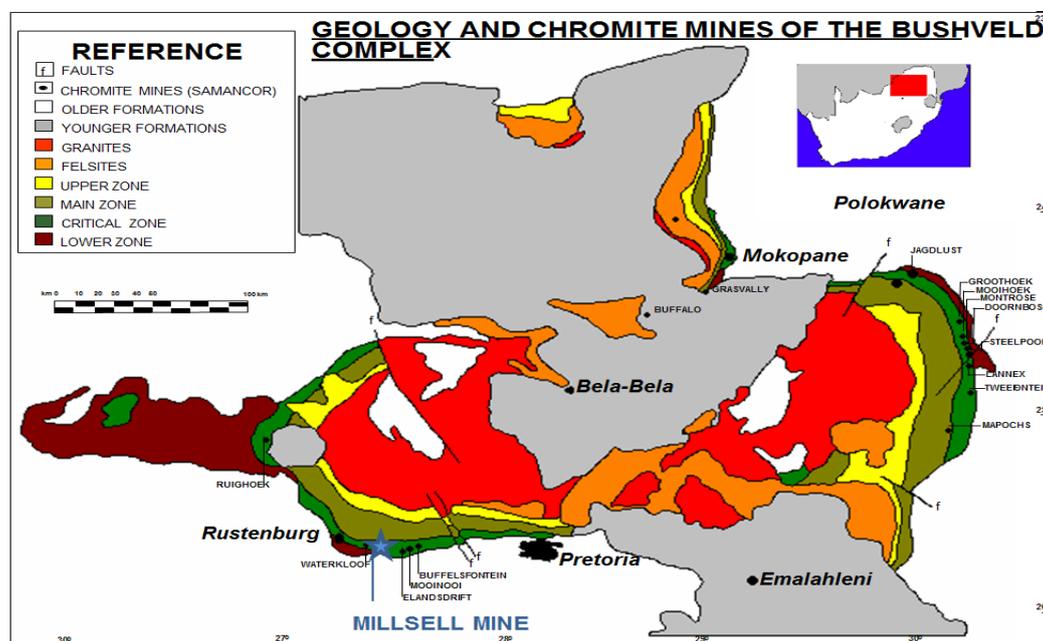
Figure 1: Regional geological map indicating Millsell Mine (Steenkamp, 2006)

The chromitite layer resources in South Africa are situated within the Rustenburg Layered Suite (RLS) of the Bushveld Complex (BC). Figure 1 depicts the regional geology and Millsell Mine location.

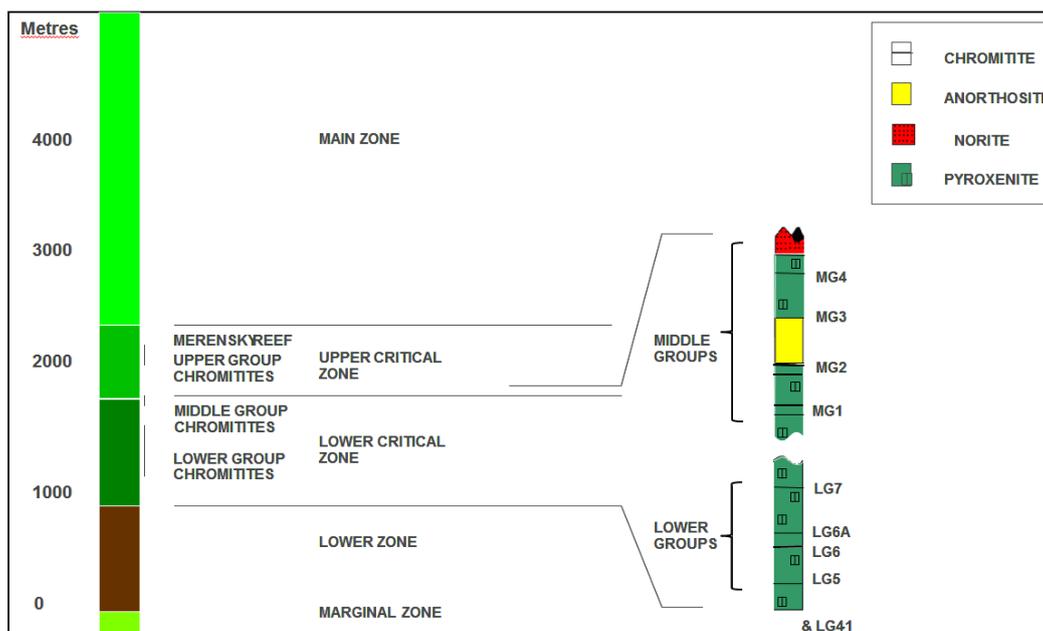
Figure 2: Generalized Stratigraphy of the Middle and Lower chromitite seams (Modified from Schurman, Grabe & Steenkamp, 1998)

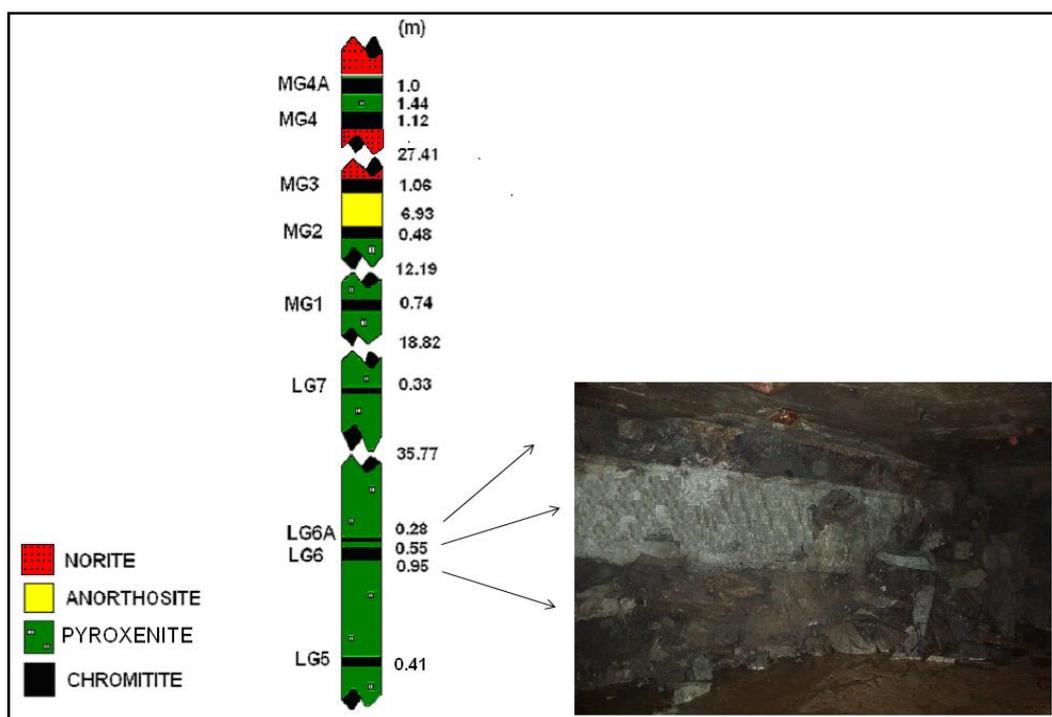
Figure 3: Stratigraphic column of the LG6 package at Millsell Mine (Steenkamp, 2006).

Economically the most important of the LG chromitite layers is the LG6 (average 0.96m thick) and the overlying LG6A (average 0.26m thick), separated by an internal middling pyroxenite parting (average 0.66m thick). The pyroxenite layer separating the LG6 and LG6A chromitite layers varies in thickness laterally. The internal middling pyroxenite increases in thickness to more than 2.0m on the north-western portion of the farm Kroondal 304 JQ. The stratigraphic column of Millsell Mine is illustrated in Figure 3 (Steenkamp, 2006).

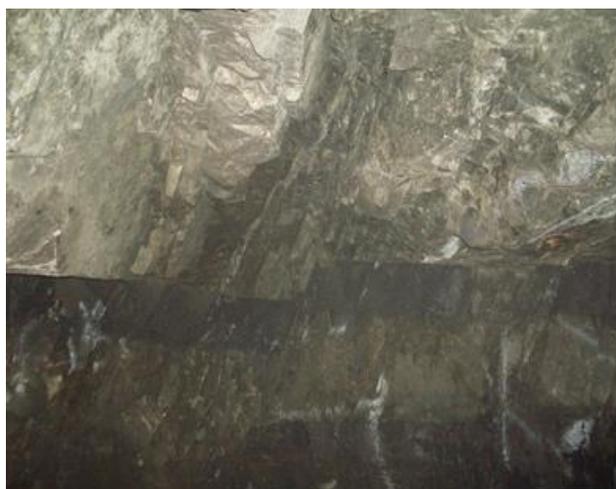
Photo 1: NNW - SSE trending normal faults

A major fault trending north-south to the east of the Millsell Mine, with a downthrown to the east, has a scissor effect northwards with a downthrown to the west, and peters out further northwards (Steenkamp, 2006). The photographs below depict the typical faults found at Millsell.

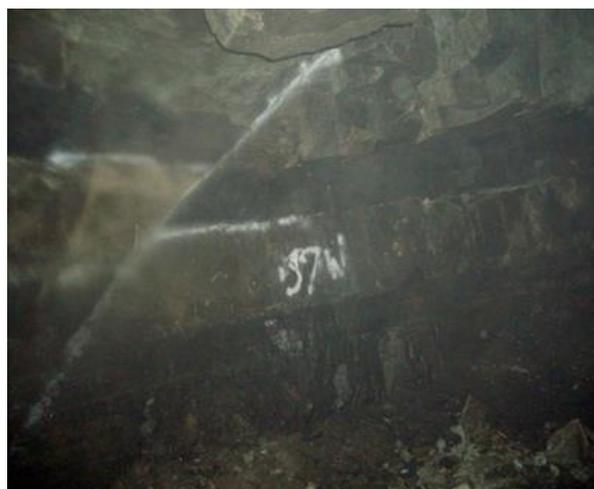
Photo 2: E-W trending reverse fault

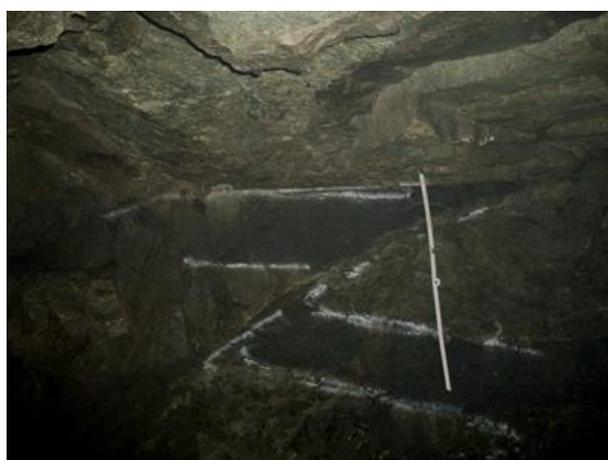
Photo 3: E-W trending thrust faults

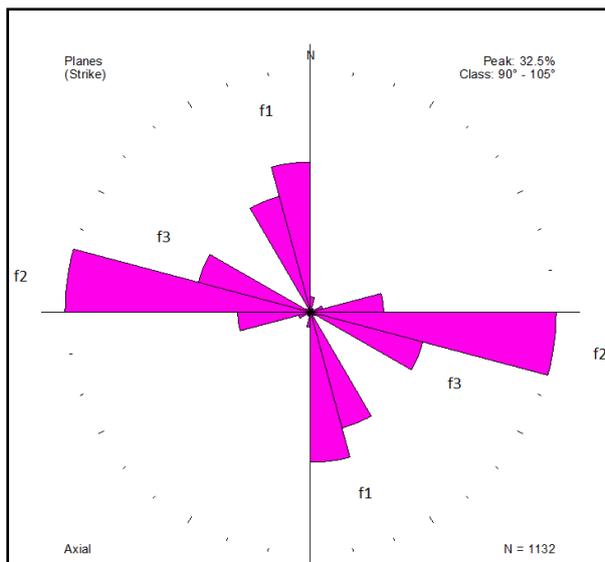
The Fault rose diagram in figure 4 is set at 15° increments. The dominant orientation is 90 to 105°. This represent 32% of the total fault population of the fault orientations measured at Millsell Mine (number of fault measurements N= 1132). A secondary distribution peak is orientated between 150 to 180° representing the f1 set.

Figure 4: Rose diagram of the fault system

The rose diagrams in figure 4, 5 and 9 are an orientation defined circular representation of the faults, joints and dome planes, data measured at Millsell mine. The azimuth (measured as strike direction) for each individual plane is plotted as a line on the circular diagram. The density distribution of the lines are plotted in fixed intervals and displayed as a circular histogram. The density distributions are symmetrically represented around a hypothetical perpendicular line, creating an inverse distribution over 180°.

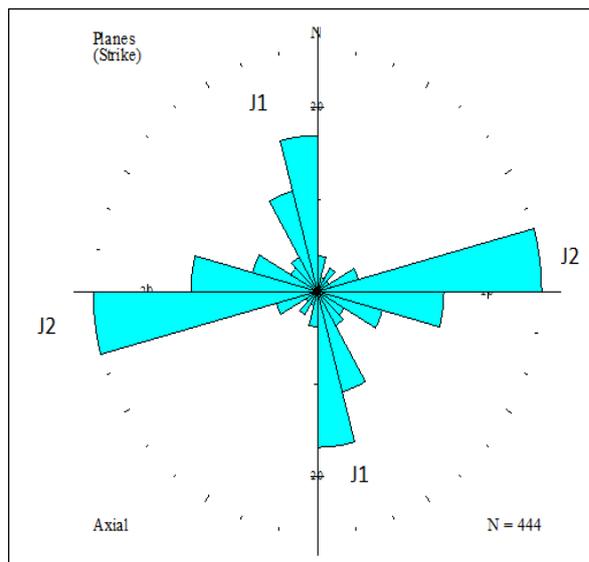
Figure 5: Rose diagram of jointing system

A prominent joint system is developed throughout the underground workings trending NNW- SSE (156°), dipping mainly westwards and E-W (96°), dipping mainly south. The joint set trending at 156° is locally known as the J1 set, and the set trending at 96° is locally known as the J2 set. This conjugate joint system is sub vertical and the spacing frequency varies throughout the mining area. It may be continuous or discontinuous on strike and dip. The degree of joint roughness can be classified as smooth and separation is tight (Treloar and Steenkamp, 2000: 2).

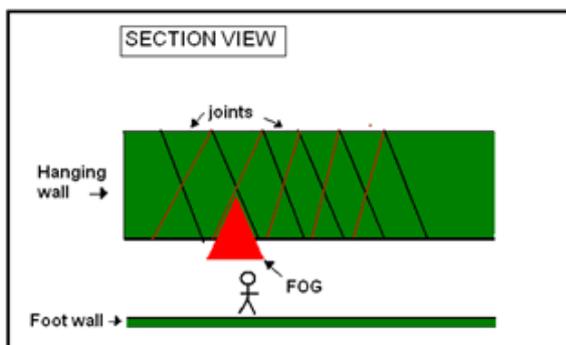
Figure 6: Intersecting joints and a FOG

When the J1 and J2 joints strike in different orientations, they may intersect each other during which key blocks form in the hanging wall and result in a FOGs (Fig 6). Joint alteration zones also occur (one meter wide) which results in altered rocks in the hanging and side wall. These joint sets can cause a channel type of failure and in conjunction with other discontinuities influence the stability of the hanging and side walls. Simple illustrative diagrams are shown below in Figure 6 and 7.

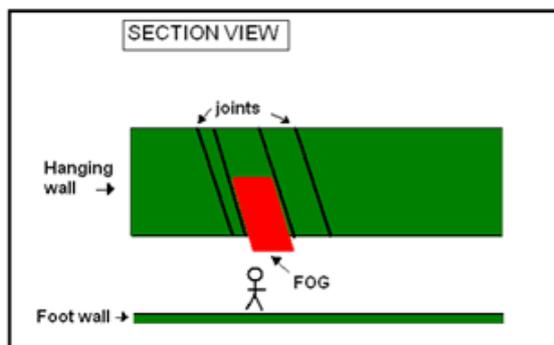
Figure 7: A channel type failure in a J1 set

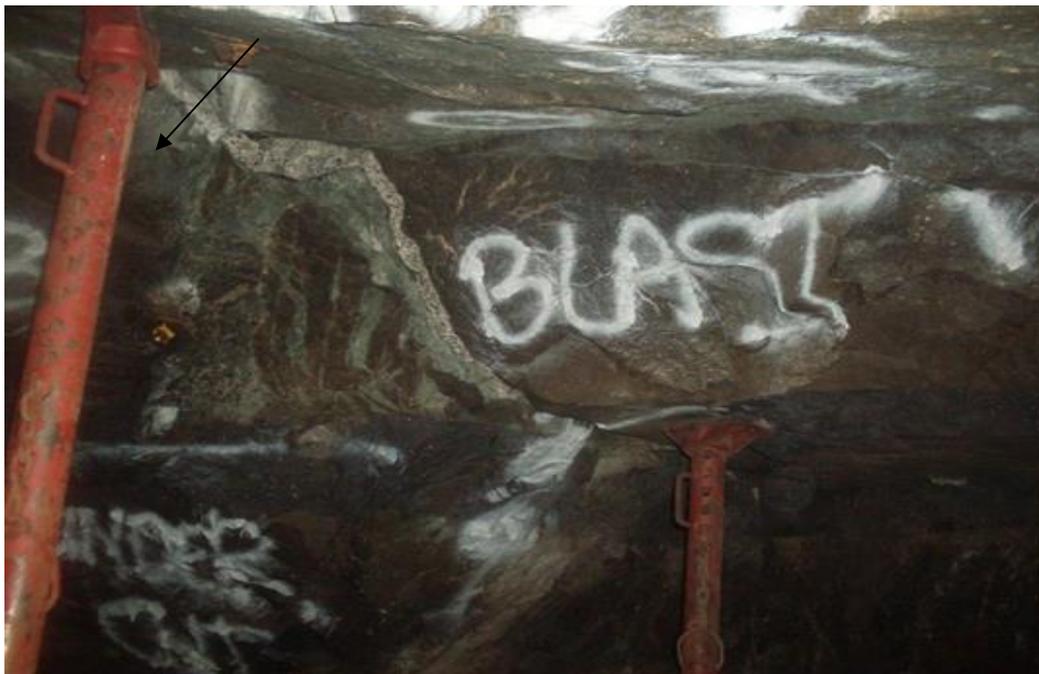
Photo 4: E-W striking pegmatite vein

The pegmatite veins are dyke like structures and often extend through the chromitite and pyroxenites, but may pinch out when intersecting the thicker underlying LG6 chromitite layer. The pegmatite veins at Millsell trend in an east-west direction. The J2s are possible indicators or precursor feeder zones of pegmatite bodies associated with potholes (Steenkamp, 2006). Pegmatite veins in conjunction with other geological structures will also result in poor and blocky hanging wall conditions.

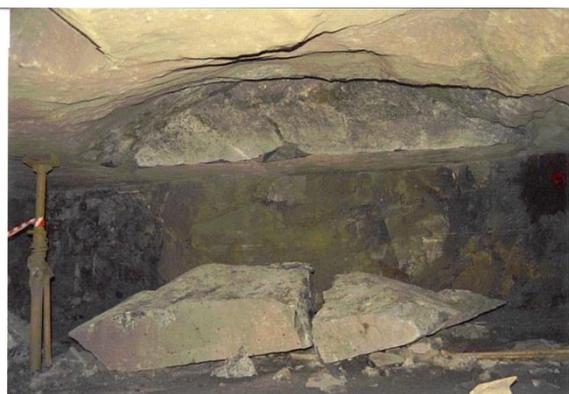
Photo 5: Fallen minor dome

Low angled compressional structures, known as domes occur in the hanging wall of the LG6 package. These dome structures range in size and extent, and are usually characterized by slickensides with serpentinised or talc infilling along their contact planes. The major domes usually intersect the chromitite seams with associated displacement in centimeters. The amount of displacement of the chromitite seam usually gives an indication of the size of the dome. Photograph 6 is used to illustrate displacements along domal splays.

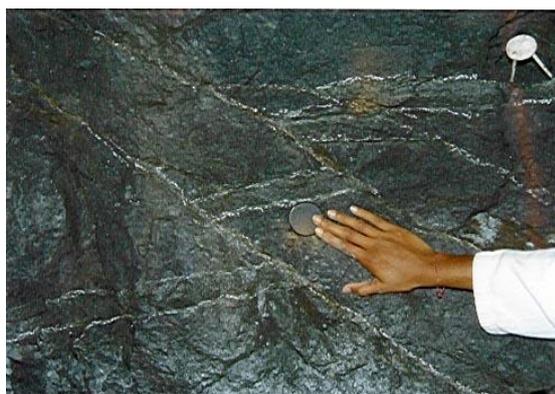
Photo 6: Displacements along dome plane

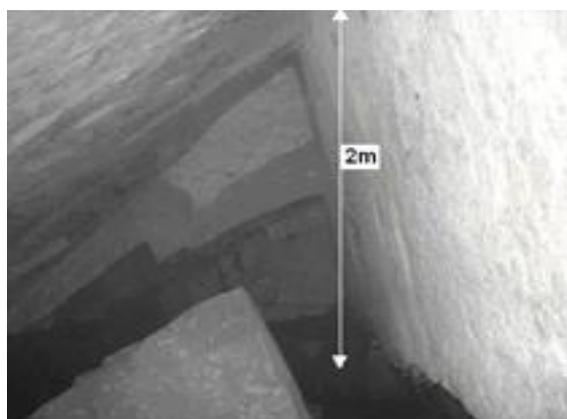
Photo 7: Fallen major dome

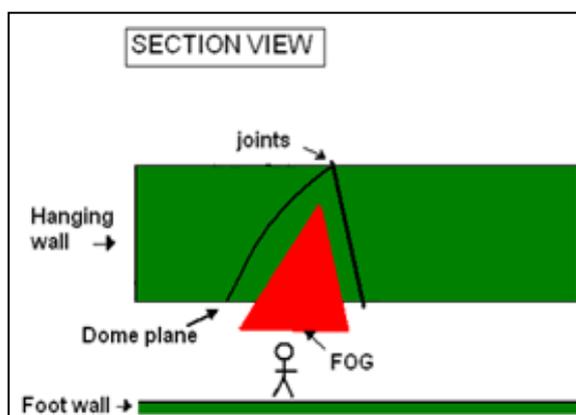
Figure 8: Dome structure fallen out along a joint

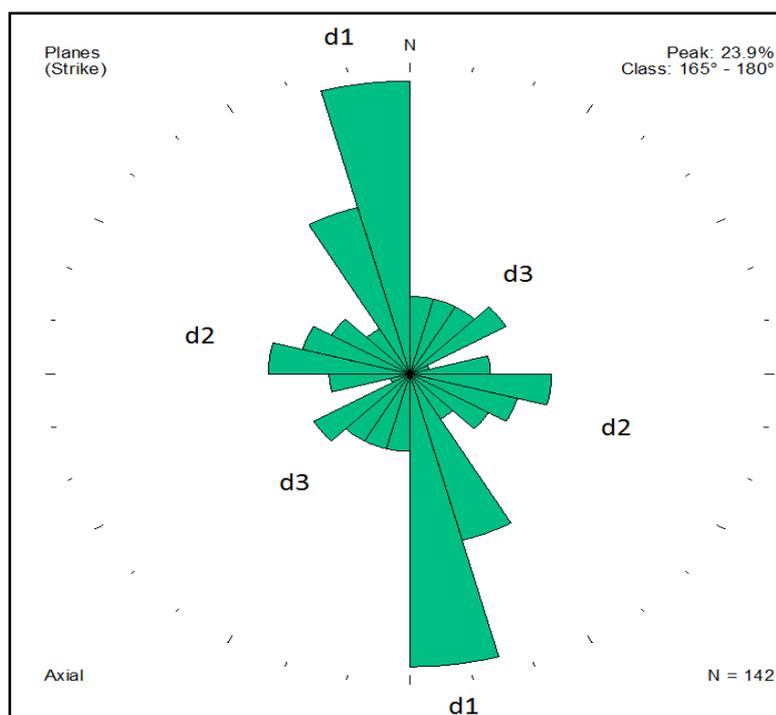
It is evident from underground mapping (and as illustrated in Figure 9 below), that there are two dominant dome orientations which are locally classified as d1 and d2. The dome planes classified as d1 are mainly orientated with their long axis sub parallel to the f1 and J1 sets. The d2 dome planes are orientated with their long axis parallel to the f2s. Certain dome planes seem to be related to E-W folding but geological mappings are insufficient to prove any relationship.

Figure 9: Rose diagram orientation's of the dome planes long axis

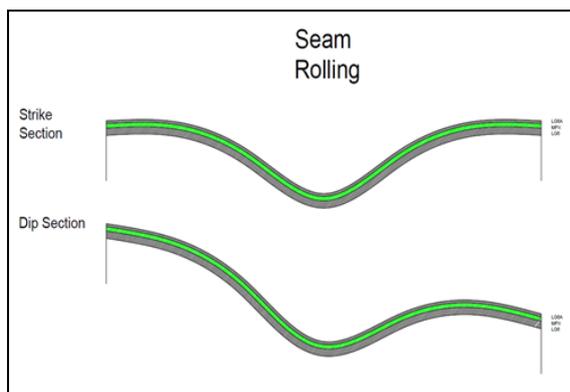
Figure 10: A slump / rolling behaviour

The different types of potholes are illustrated below in Figures 10, 11, 12, 13 and 14.

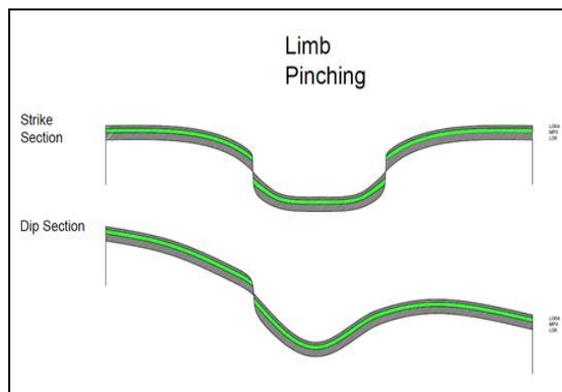
Figure 11: Chromitite layer steepening and pinches

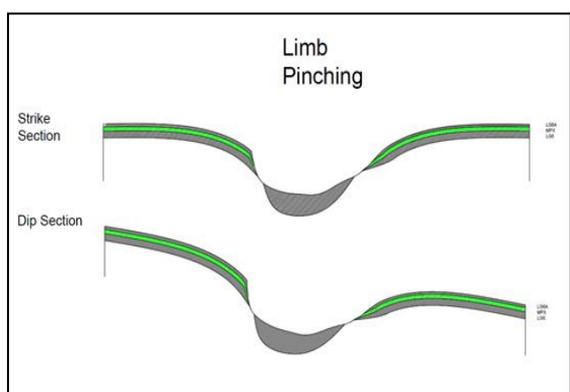
Figure 12: Chromitite layer pinches out and thickens into one chromitite seam or mass

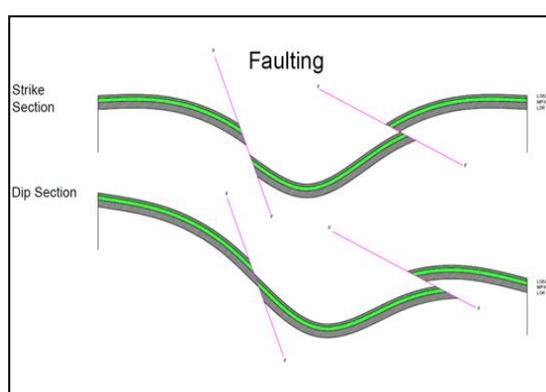
Figure 13: Pothole type with shearing and faulting along the limbs

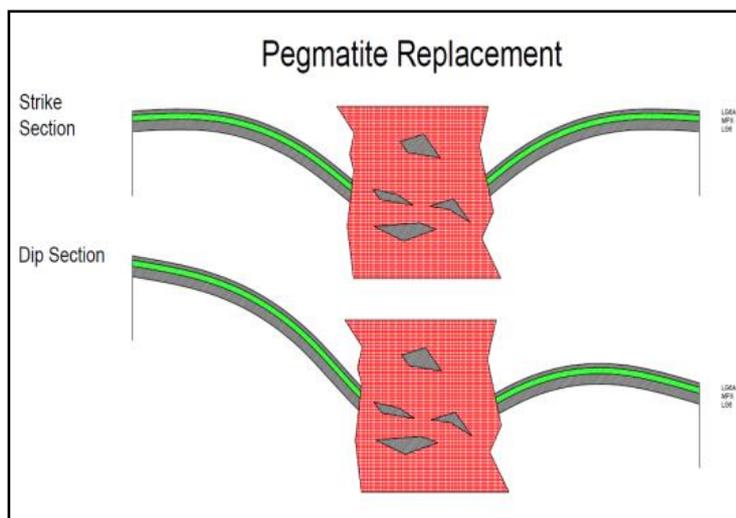
Figure 14: Pothole type associated pegmatite body

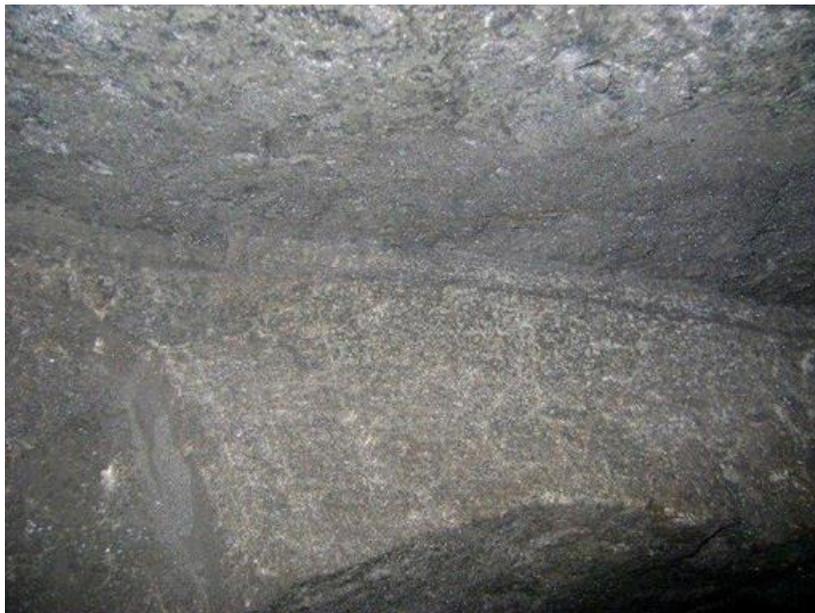
Photo 3: Disseminated layering 0.2 to 0.3m above the LG6A seam

Thin disseminated chromite stringers or bands situated in the immediate hanging wall can occur and contribute to thin beam type failures. The beam thickness between the LG6A and the disseminated layer increases in thickness in the southern portion >0.2m of the mine to >3.0m in the northern portion of the mine (Treloar and Steenkamp, 2000).

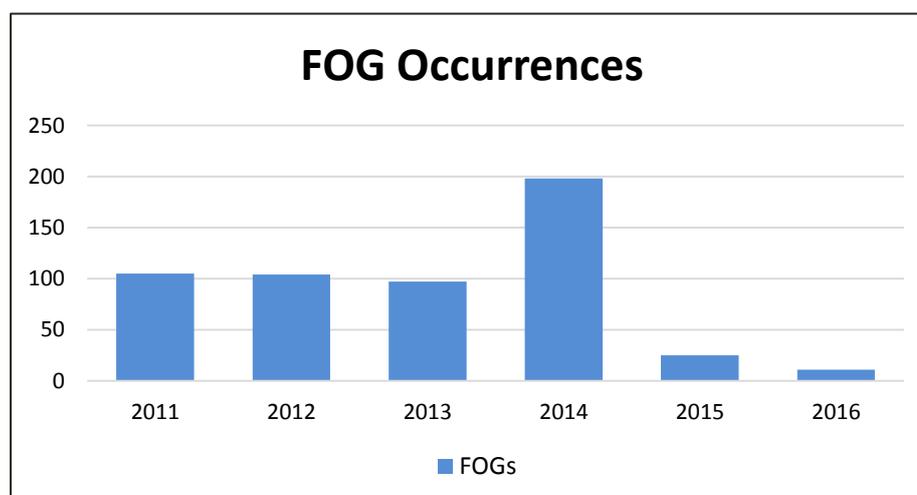
Figure 15: Fall of Ground occurrences from period 2011 to April 2016

In the past five to six (5-6) years, the mine recorded more than five hundred (500) fall of ground occurrences. (Source: WCM Rock Engineering Database, 2016). Figure 15 below shows all FOG incidents, observations and near misses where a rock has been displaced from either the hanging and/or sidewall. Over 90 percent of the above incidents were non casualty events.

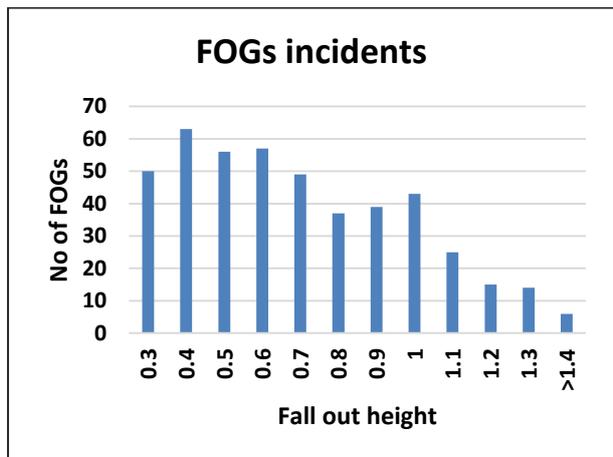
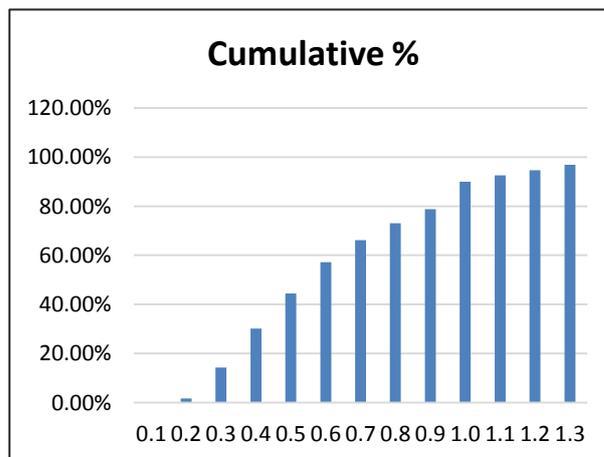
Ninety-five percent (95%) of the FOG’s are within the cumulative fall out height of 1.3m, which still falls within the support design criteria.

Figure 15: FOGs and fall out height comparison

Figure 16: Cumulative fall-out height percentage

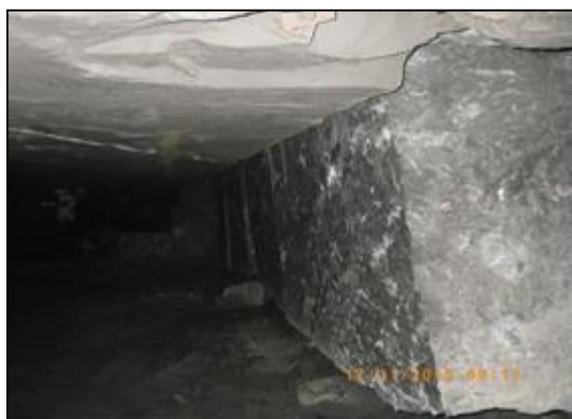
Photo 9: FOG due to near vertical joint

- **Wedge failures** brought about by the interaction of the normal near vertical joints and faults intersection with flatter low angle joints or domal splays. A number of these FOGs resulted in fall out thickness of more than 2.0m, which extends beyond the support zone of up to 1.5m.

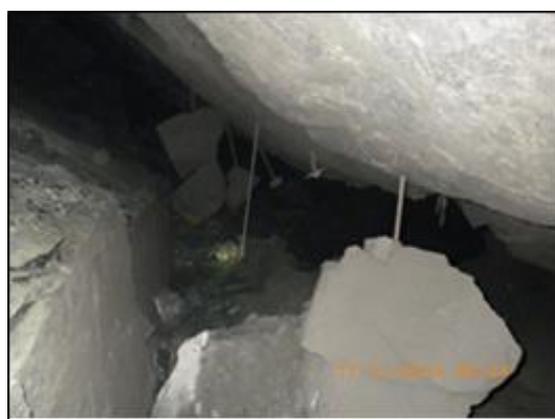
Photo 10: FOG and low angle joint

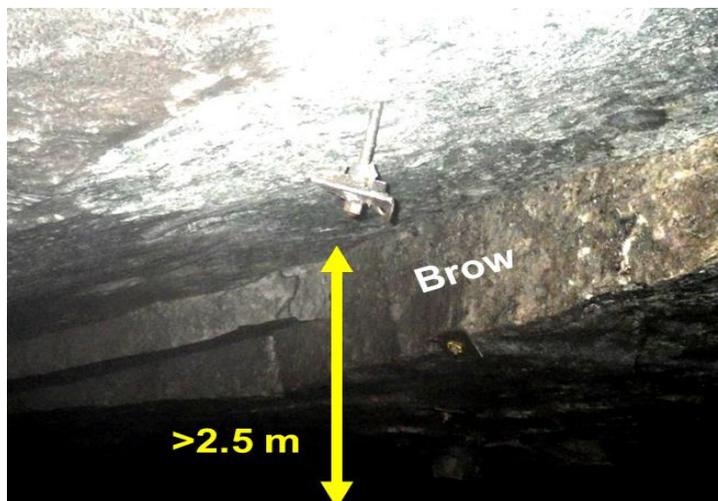
Photo 11: Brow created from FOG (disseminated layering)

- **The occurrence of disseminated layering or chromitite stringers** above the LG6A seam contributes to beam type failures (Treloar and Steenkamp, 2000 2). Large falls of hanging were recorded in cases where the thickness of this beam is less than 1.0m. Observations indicate that beam thickness of less than 1.0m tends to fall out mainly during blasting, but beam thicknesses of more than 1.0m tend to be fairly stable.

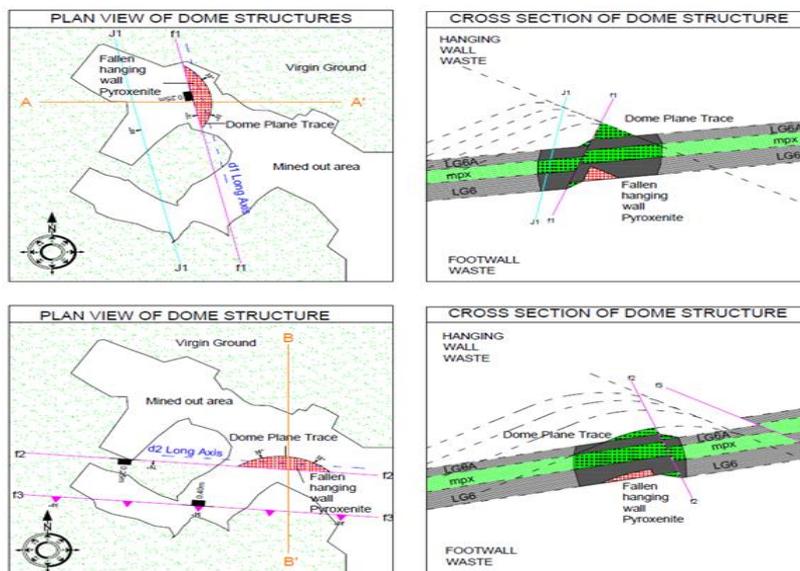
Figure 17: Illustration of the intersection geological structures

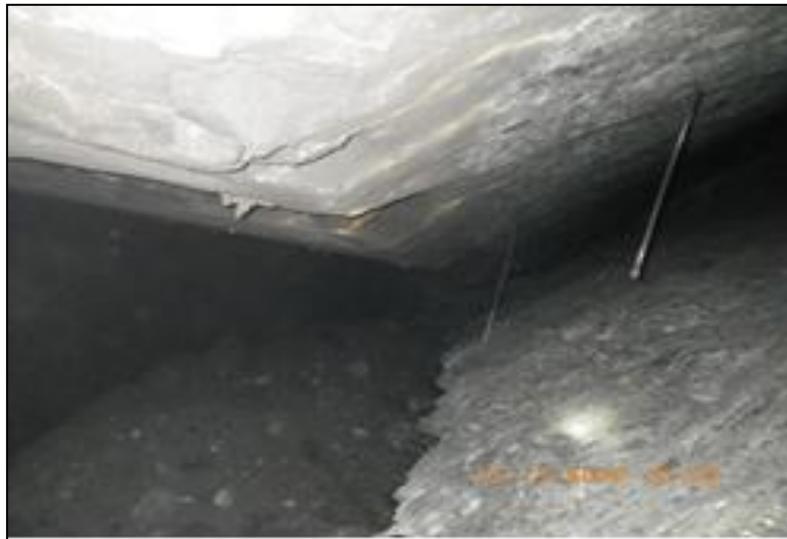
Photo 12: FOG on low angle curved joint

- **Low angle curved joints intersections** often results in FOGs. Production personnel often find it difficult to identify these structures with the naked eye. The application of technology to identify these structures has proven critical to the correct decision making in addressing the geological structures.

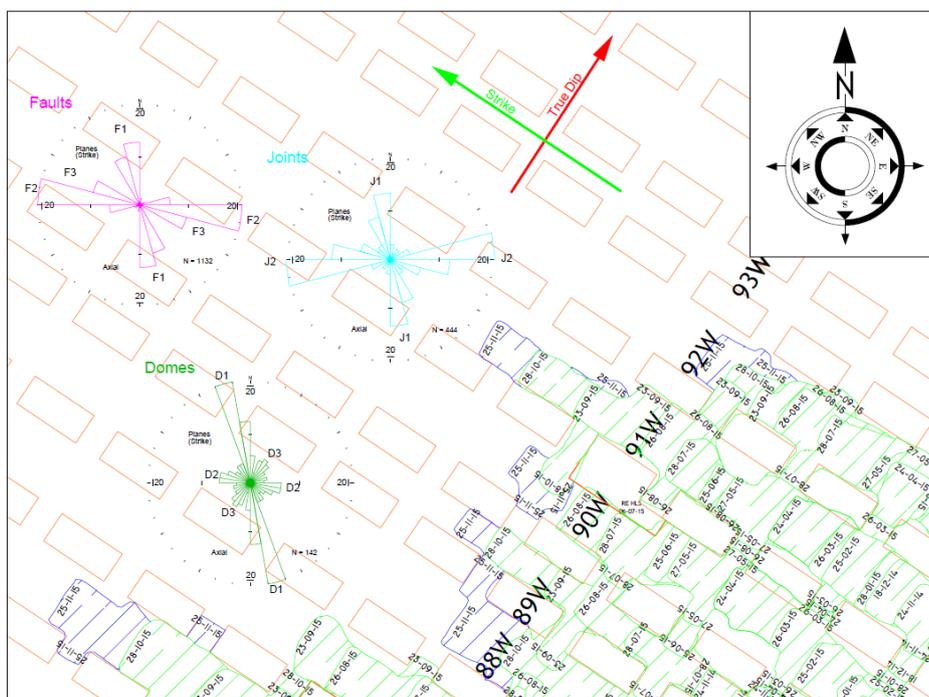
- **The previous mine design** comprised of rectangular board and pillar with bearing NW / SE layout. Board face length were typically 14m wide with 6m holings. The long length of the board exposes the geological structures over their critical span, and this was found to be contributing to the large scale falls of ground.

Figure 18: Previous design was 14m board widths with 12m X 6m pillars

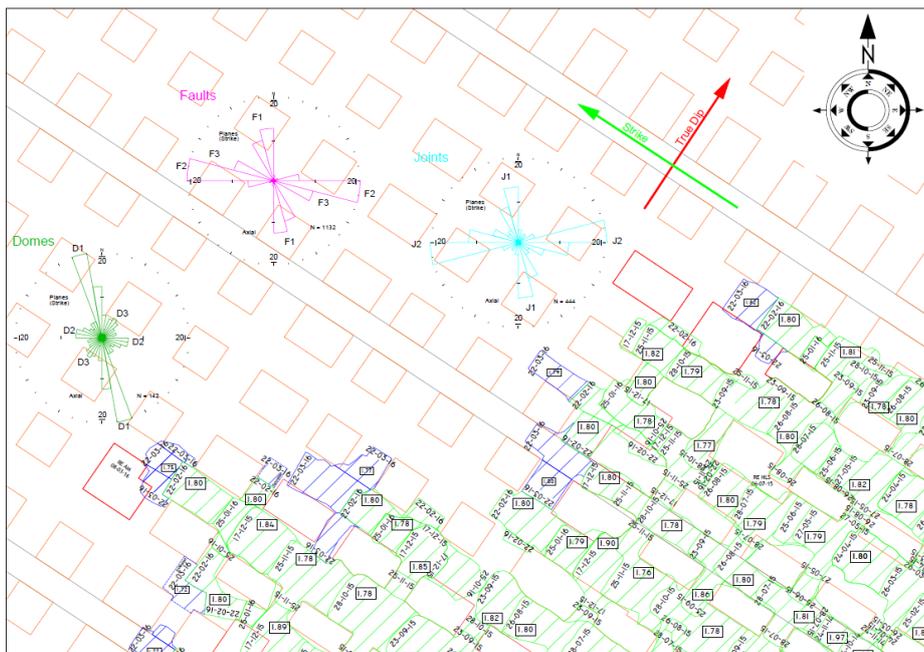
The planned pillar dimensions and critical board spans were scrutinised in order to determine the optimum layout. Inevitably the design of the mine was revised. By influencing the input process of the mining strategy combined with layout redesign, a more predictable outcome was achieved. Changing from 14m board widths with rectangular 12m by 6m pillars to the 10m by 10m square configuration with board width of 10m for mining at a depth below surface of 400m, result is a 5% reduction in extraction ratio but improves pillar stress with a 60 % reduction and yielded a 54% increase in pillar factor of safety.

Figure 19: Revised pillar design with 10m X 10m pillars

The table belows illustrates the impact of revised layout to the extraction ratios and factor of safety calculations.

Table 1: Pillar calculations for 12m X 6m vs 10m X 10m pillars at 400m BS (Salamon and Munro, as cited in Ryder and Jager, 2002).

Effective face length has been reduced by 28%, i.e. more than a quarter. When extrapolating the mean azimuth of the individual geological discontinuities as obtained from the Rose diagram plots on to the mines plan it is observed that the reduction of exposed discontinuity, not supported by a pillar as per individual layout is directly proportional to the reduction of face length. The revised layout resulted in a 28% reduction in the unsupported length of the geological discontinuities.
